Peralta Community College District

FUSION Assessment 2016

Peralta FUSION Assessment 2016

Facility Executive Summary

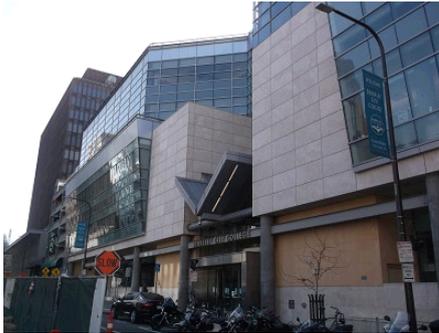
Berkeley City College is part of the Peralta community college district located in Berkeley CA. This six story building has a total of 165,690 GSF. The building was originally constructed in 2006 with no major renovations to date, 2016. A major remodel consists of but is not limited to a full gut, face to stud remodel with replacement of all systems.

1 Replace cooling tower.

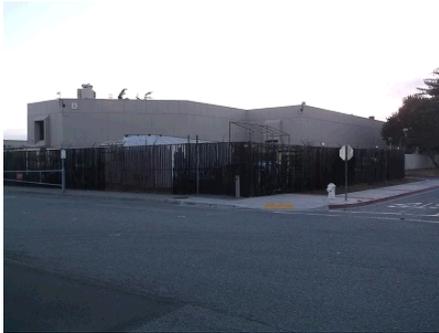
The Auto Shop building is located on the southwest side of the campus. This two story facility consists of classrooms, classroom labs, auto shops, faculty offices, and storage rooms, for a total of 30,176 GSF. The building was originally constructed in 1970 with a cosmetic remodel in 1989 with no major remodels to date 2016. A major remodel consists of but is not limited to a full gut, face to stud remodel with replacement of all systems.

- 1 Replace roof.
- 2 Replace 9"x9" floor tiles.
- 3 Replace air handlers.
- 4 Replace two sink leaks.
- 5 Replace drinking fountains.

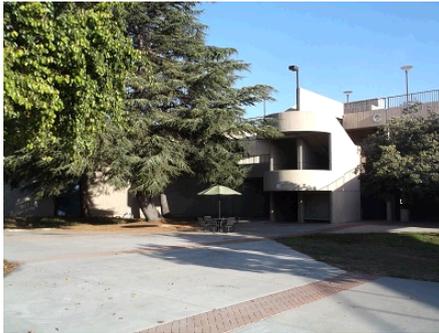
The Life Science Building is located near the center of the College of Alameda campus between the Auto Shop building and the Gymnasium. This two story building contains several spaces, including classrooms, classroom labs, faculty offices, division offices, and storage/custodial areas, for a total of 20,991 GSF. The building was originally constructed in 1970 with no major remodels to date, 2016. A major remodel consists of but is not limited to a full gut, face to stud remodel with replacement of all systems.

- 1 Replace original air handler.
- 2 Replace lab sink.
- 3 Replace metal toilet partitions.
- 4 Replace 9"x9" floor tiles.
- 5 Replace metal exterior doors.
- 5 Repair/replace incandescent lighting.
- 6 Replace windows, room 212.

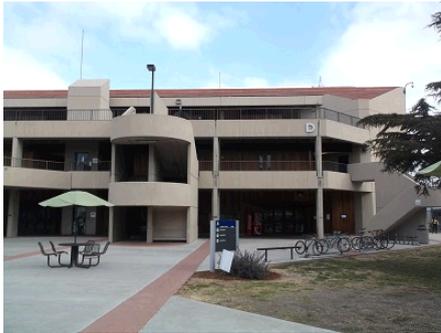
The Classroom Building-D is located near the center of the campus just across from Building A between Buildings C and F. This three story facility contains classrooms, labs, faculty and staff offices for a total of 50,888 GSF. The building was originally constructed in 1970 with a remodel in 1980 with no major remodels to date, 2016. A major remodel consists of but is not limited to a full gut, face to stud remodel with replacement of all systems.

- 1 Replace roof.
- 2 Replace drinking fountains.
- 3 Replace/add DI water system.
- 4 Replace 9"x 9: floor tiles.
- 5 Replace metal toilet partitions.
- 6 Replace emergency lighting battery's.

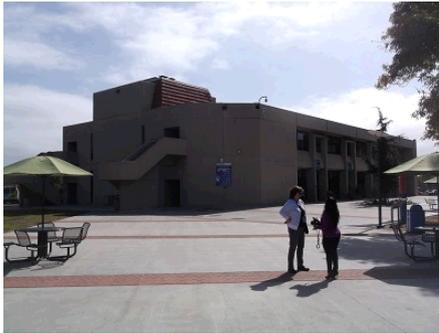
The Student Union Building F is located in the southeastern quadrant of the campus across from the Learning Resource Center and Building A. This two story facility contains areas used as assembly areas, a cafeteria, kitchen, and the student bookstore, for a total of 22,762 GSF. The building was originally constructed in 1970 with a remodel in 1998 with no major remodels to date, 2016. A major remodel consists of but is not limited to a full gut, face to stud remodel with replacement of all systems.

- 1 Replace drinking fountain.
- 2 Replace emergency lighting battery's.
- 3 Replace toilet.
- 4 Ceiling leak, RM 104.

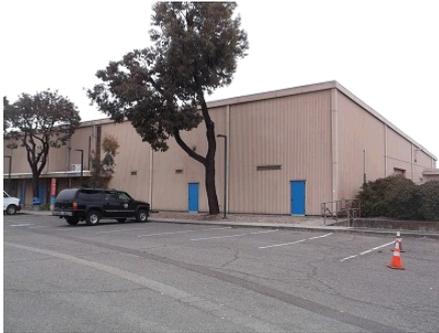
The Aero Tech Building, A is located on Harbor Bay Parkway which is near the Oakland Airport. This one story building contains the Aero Tech's Division labs as well as several classrooms, and offices for a total of 10,908 GSF. The building was originally constructed in 1969 with no major remodels to date, 2016. A major remodel consists of but is not limited to a full gut, face to stud remodel with replacement of all systems.

- 1 Replace electric panel.
- 2 Replace gutters.
- 3 Replace gas boiler.
- 4 Replace metal toilet partitions.
- 5 Replace gang sink.
- 6 Replace heating piping.

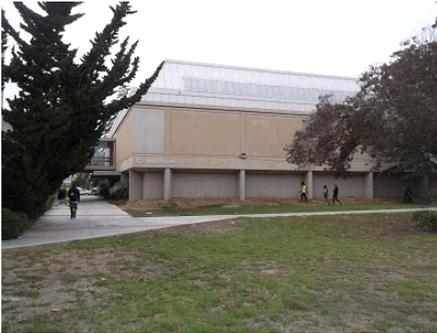
1 Replace showers.

2 Replace belt guard on dryer.
