PERALTA COMMUNITY COLLEGE DISTRICT

Merritt College  
2017 Facilities & Technology  
Master Plan  
Update

BOARD APPROVED  
March 13, 2018

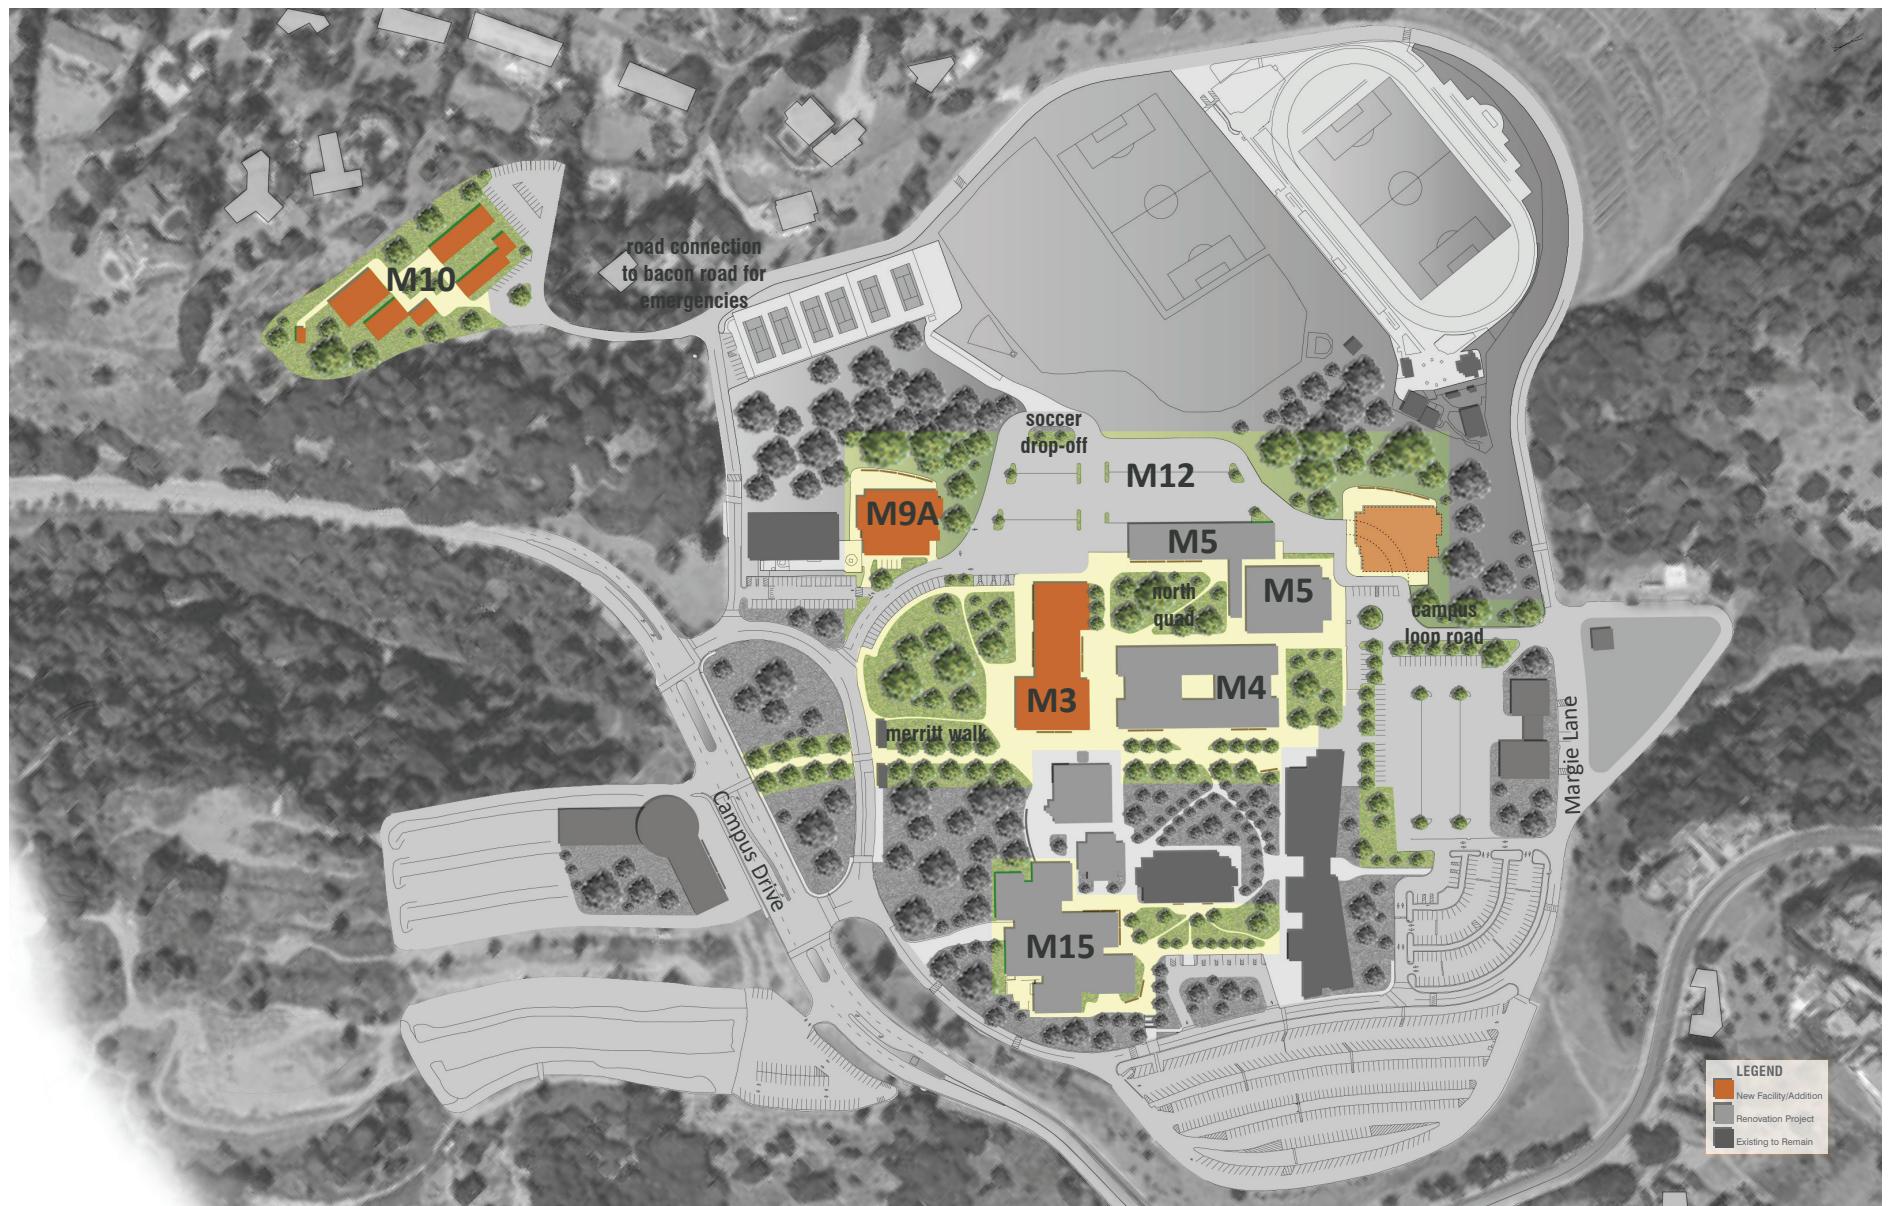
## 2017 Facilities Master Plan Priority Projects

<b>INFRASTRUCTURE</b>
M1	Replace All Campus Major Electrical Equipment
M2	Civil Infrastructure Replacements
	<b>FACILITIES*</b>
M3	<b>Replacement Building A</b>
M4	<b>Renovate Building D</b>
M5	<b>Renovate Building E and F</b>
M9A	<b>Combined Child Care Center &amp; Child Development Center</b>
M10	<b>Horticulture Complex Replacement</b>
M11	Kinesiology Physical Fitness Addition
M12	<b>Site Improvement Projects</b>
M15	<b>Renovate Partial Building R</b>
	<b>TECHNOLOGY</b>
M13	Main Campus Complete Wi-Fi Deployment
M14	Main Campus Complete Network Upgrade Project

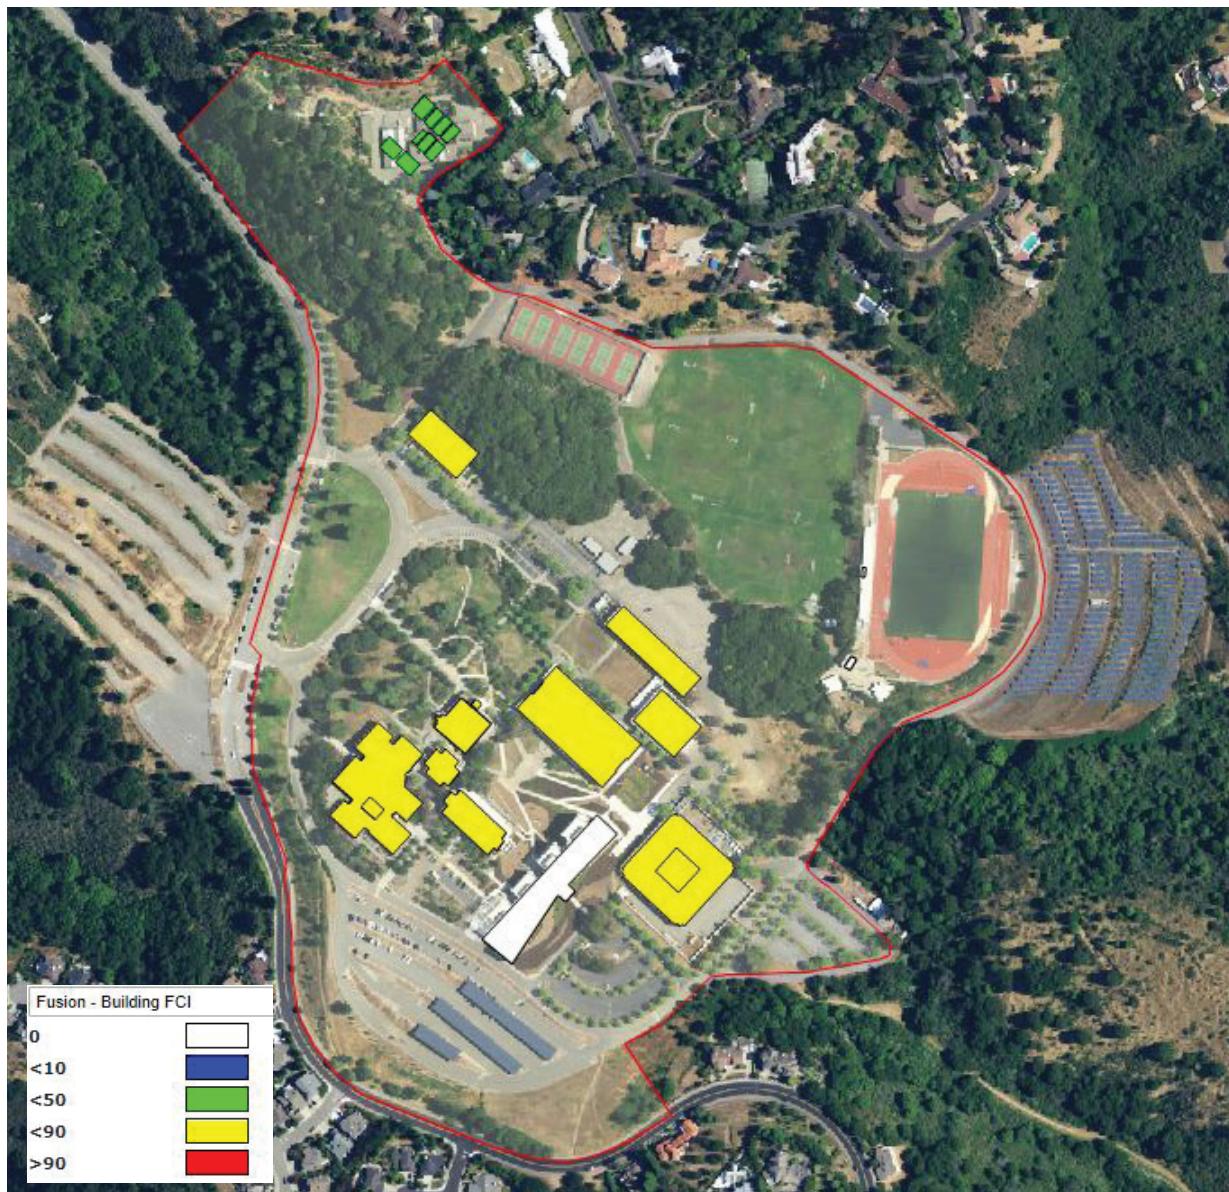
**Figure 2.3: State Facility Condition Index**

The State Facilities Condition Index (FCI) is a measure of the condition of a building relative to the replacement cost of the building. FCI does not measure the suitability or functionality of spaces.

$$\text{FCI \%} = \frac{\text{current repair cost}}{\text{replacement cost}}$$

- Blue = Good (Repair Costs less than 10% of Replacement)
- Green = Fair (Repair Costs between 10 - 50% of Replacement)
- Yellow = Poor (Repair Costs between 50 - 90% of Replacement)
- Red = Very Poor (Repair Costs over 90% of Replacement)

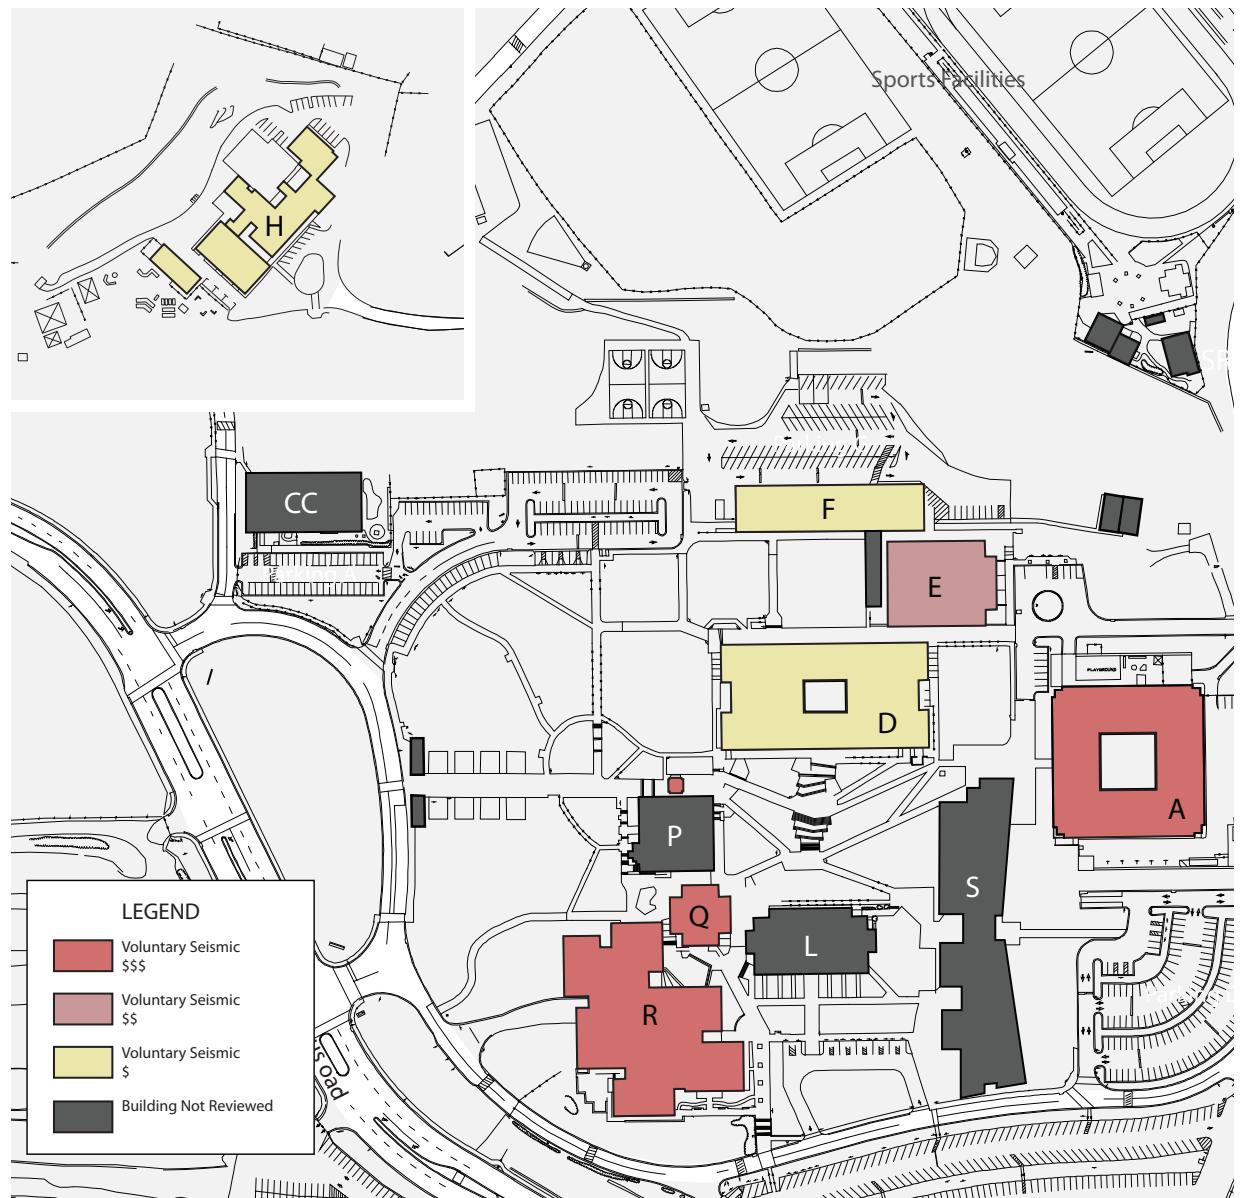
**Figure 2.6: Structural Voluntary Upgrade Analysis**

The Master Plan for the Merritt College campus includes both renovation and replacement of existing structures. The existing inventory of buildings includes a variety of structural systems, and the specific structures included within our scope of work for the District were primarily reinforced concrete buildings designed in the 1960's and 1970's, with the exception of the buildings at the Horticulture Center. This structural assessment,<sup>1</sup> in collaboration with other disciplines' assessments, is intended to assist the District's team in preparing for the future of this campus.

Our approach to this structural assessment began with the review of the existing as-built structural plans, the review of the structural assessment report from 2008 by WLC architects and KPW structural engineers, and site visits to the Merritt campus. Once the existing conditions were assessed, collaboration with the District's team enabled us to provide structural recommendations for future planning. Structural analysis will be required for each future project to identify specific deficiencies and retrofit requirements.

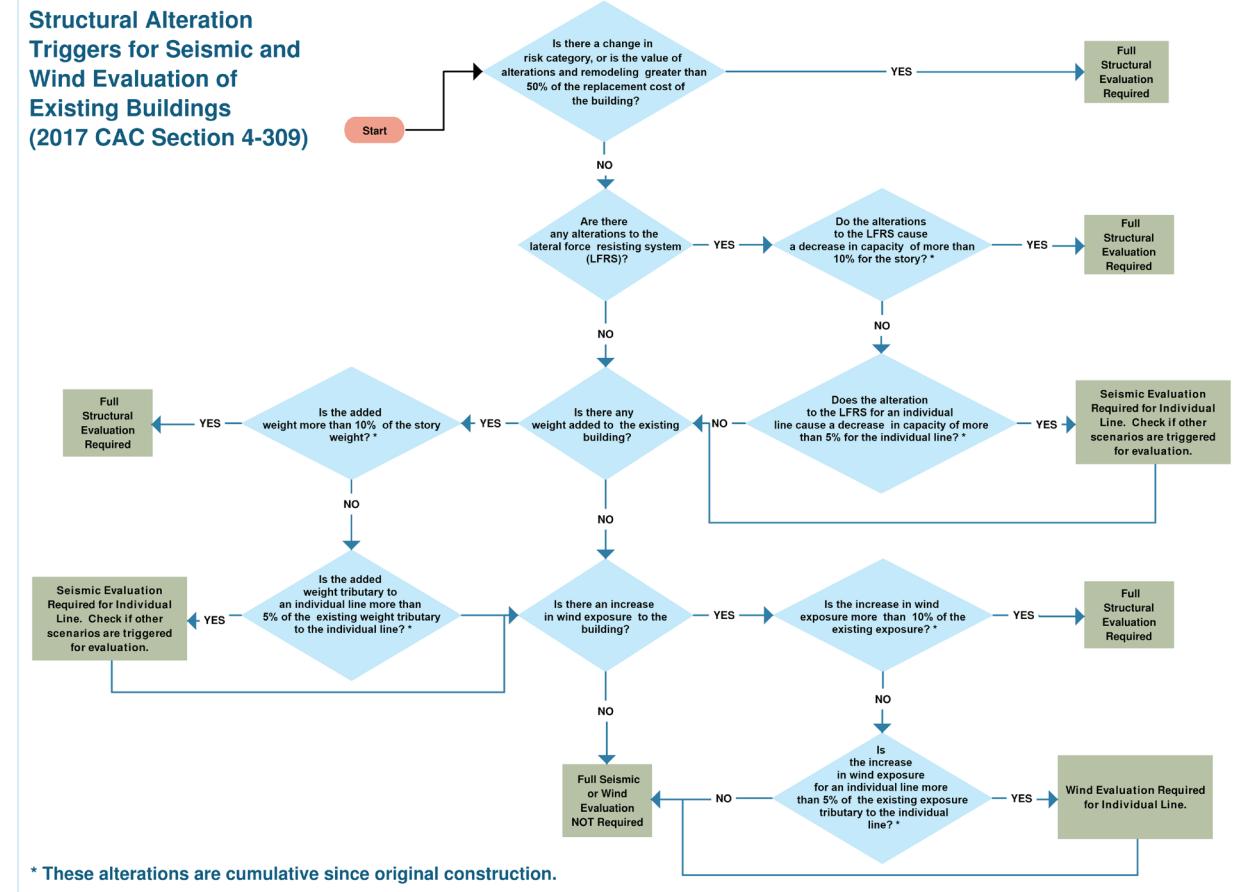
**Figure 2.7: Mandatory Structural Triggers Flow-Chart**

**Financial:** If the cost of the reconstruction, alteration, or addition of the project exceeds 50 percent of the replacement value of the existing building, then a required rehabilitation is triggered.

If one of the above triggers is met, and a full mandatory evaluation is required, the existing building must be analyzed, and retrofitted if necessary, to meet current code. If the above triggers above are avoided, then a mandatory evaluation is not required. However, the District has the option of providing a voluntary seismic upgrade to address any deficiencies that are not otherwise triggered.

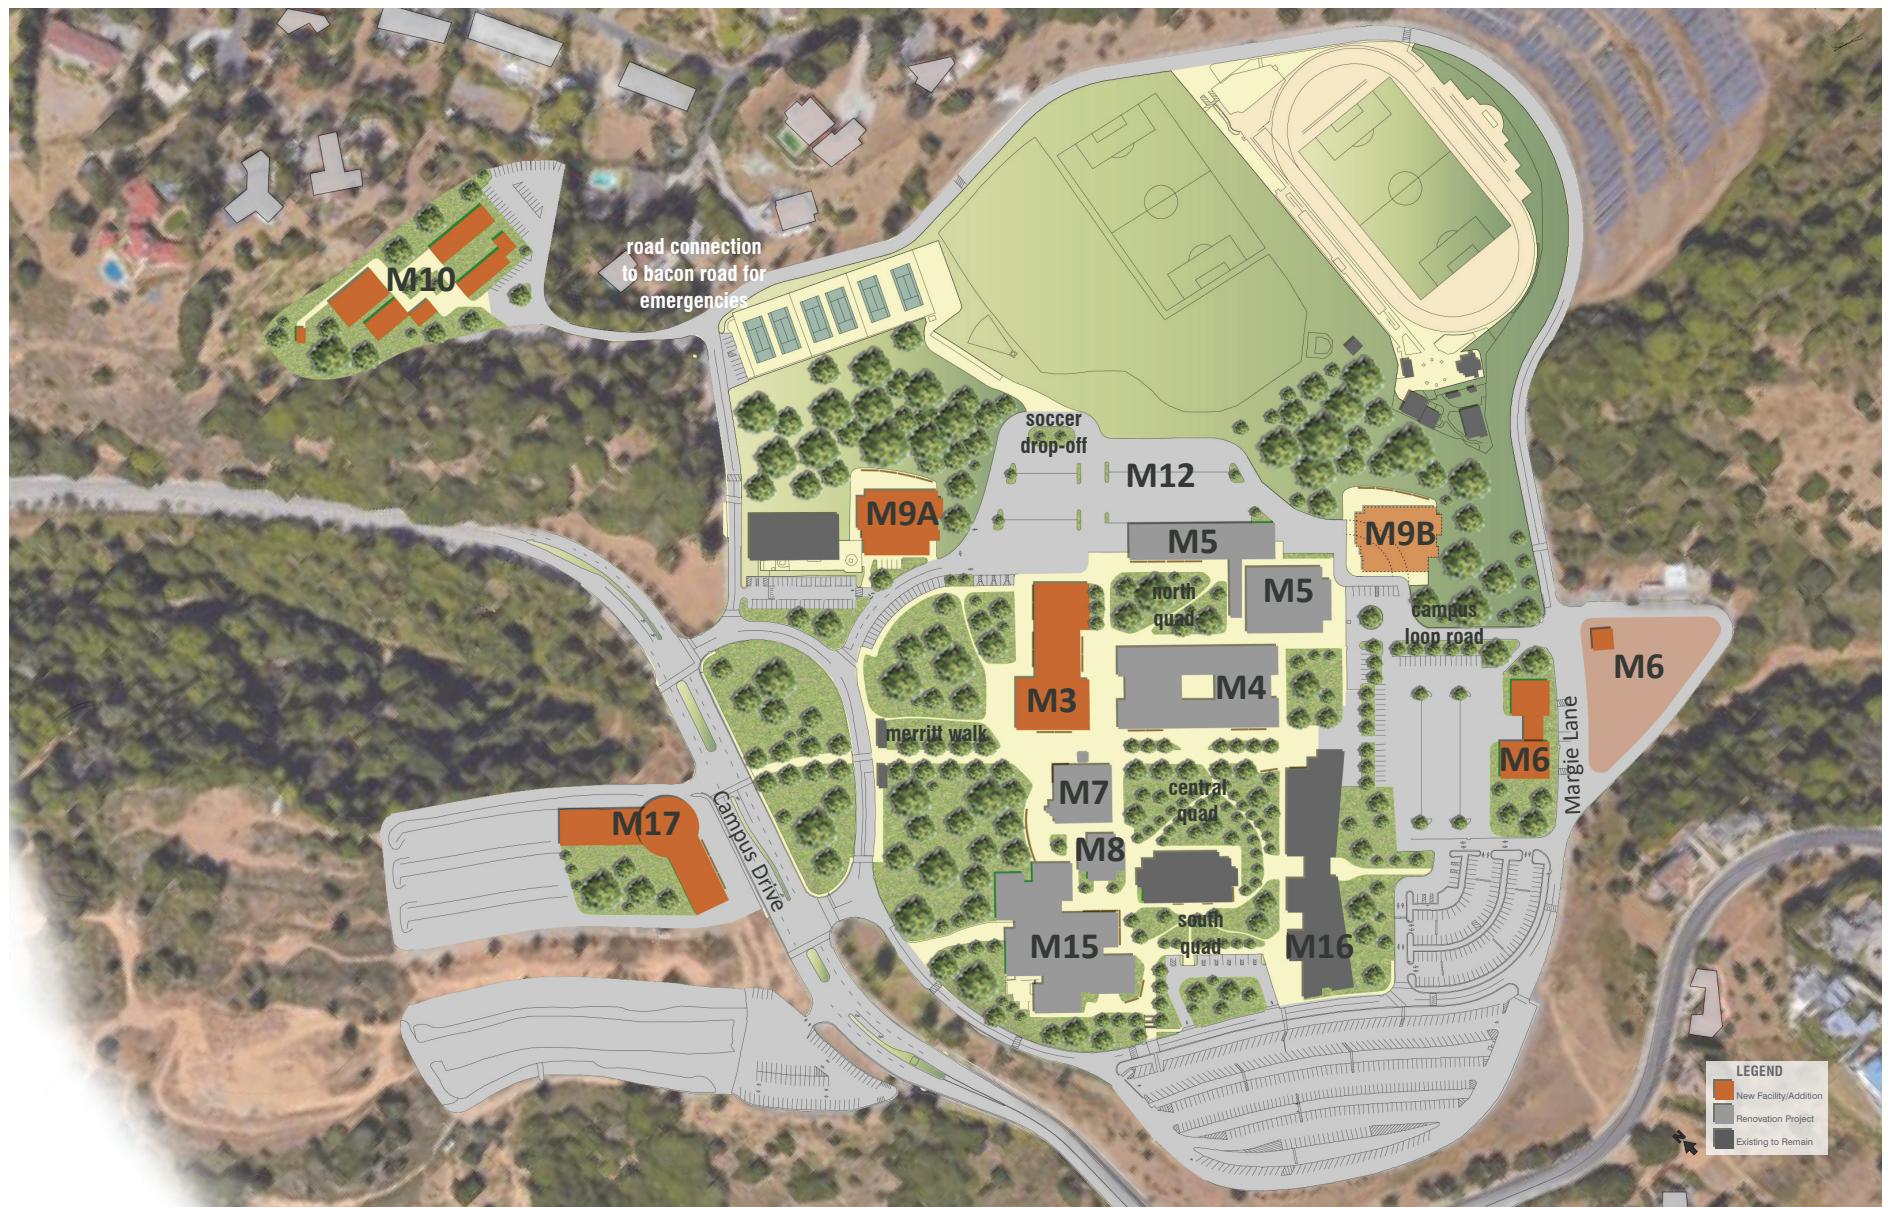
Figure 3.1: 2017 Facilities Master Plan

\* Bolded Projects are depicted on the Master Plan (Fig. 3.1)

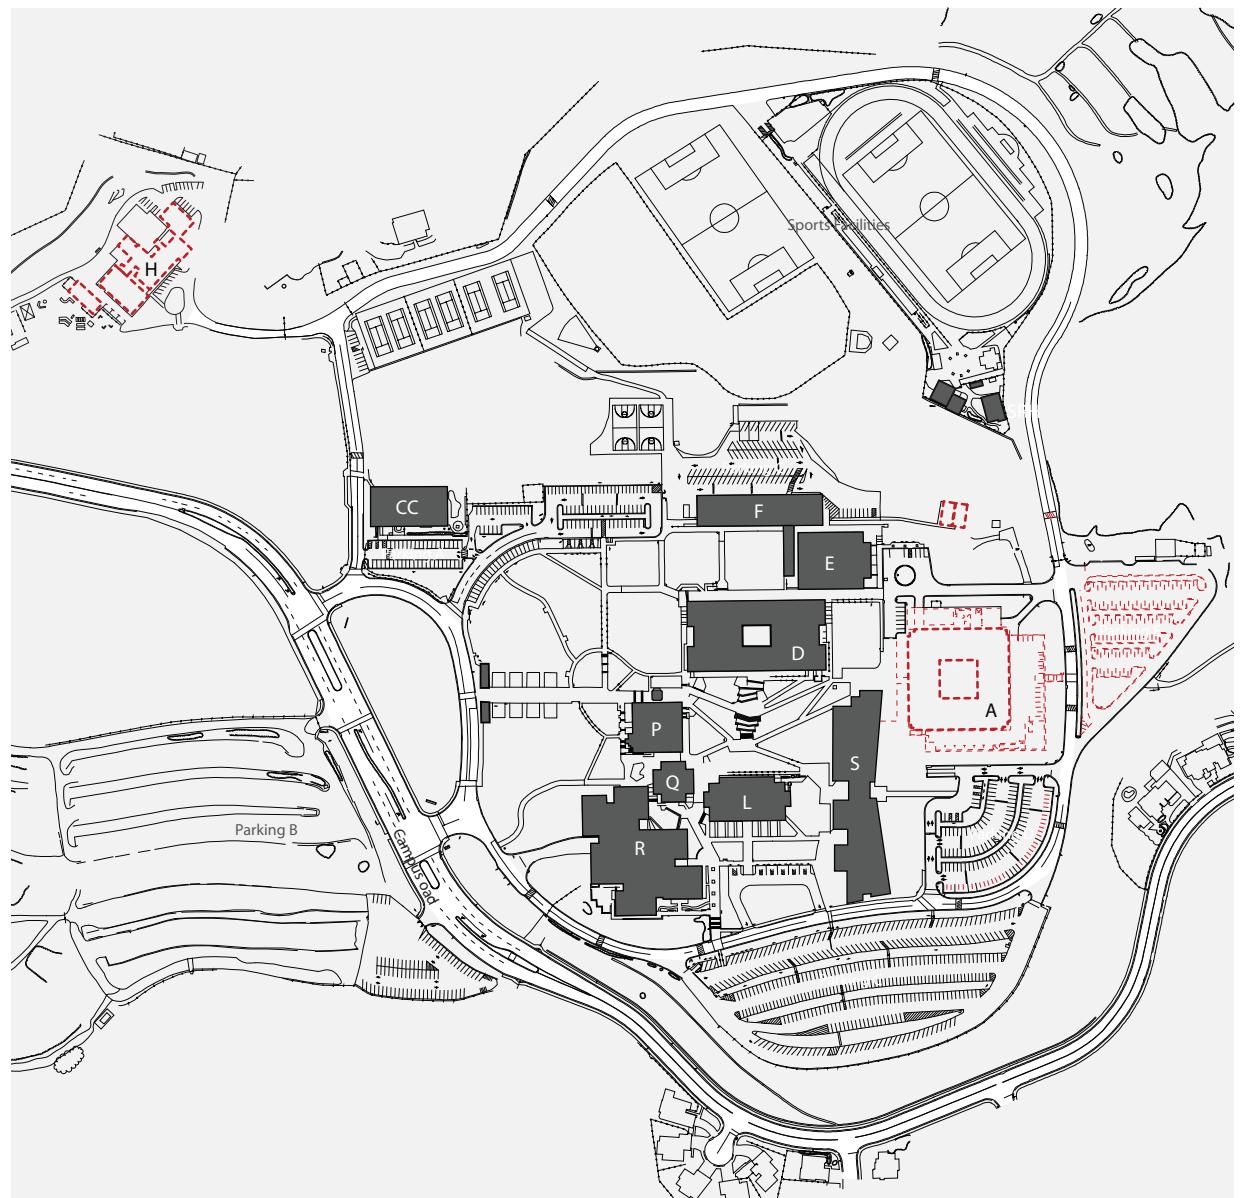
Figure 3.3: Draft Facilities Master Plan Buildings to be Demolished

The Master Plan proposes to demolish the following buildings (shown as dashed red outlines in Figure 3.3) for their associated reasons:

RATIONALE FOR DEMOLITION	
A	More expensive building to retrofit; remote from rest of campus
Hort	Buildings are end of life; configuration does not serve current teaching pedagogies for Horticulture

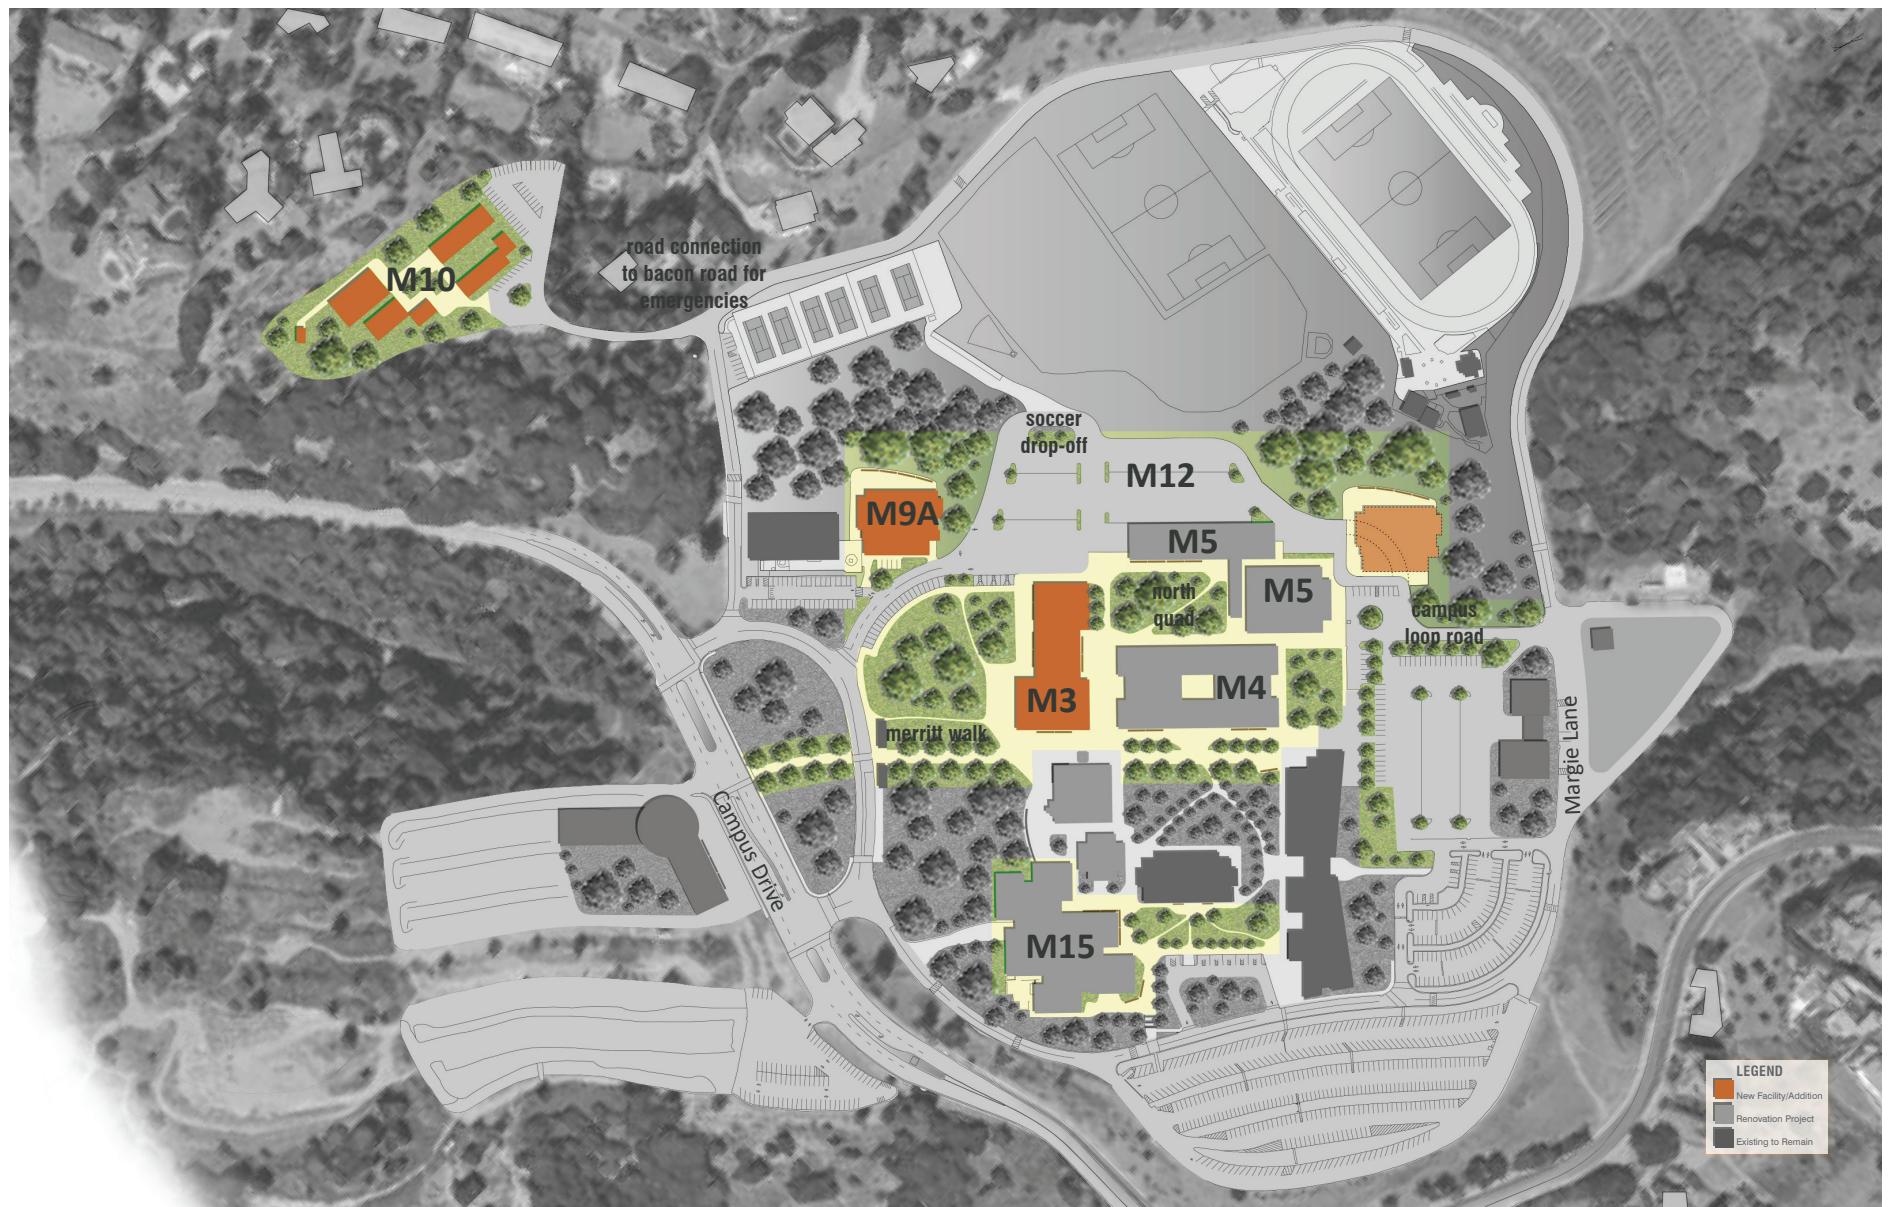
Figure 3.5: 2017 Facilities Master Plan for Priority Projects Only

The priority projects selected are shown in Figure 3.5 and listed below:
