Peralta Community College District

FUSION Assessment 2016

Peralta FUSION Assessment 2016

Facility Executive Summary

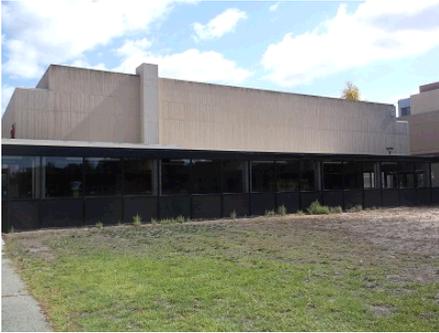
Facility: \Peralta Community College Dist\Merritt College\0003 GYMNASIUM - E
Address: 12500 Campus Dr., Oakland, CA 94619

- 1 Replace circulation pump.
- 2 Replace electric water heater.
- 3 Replace battery's emergency lighting.
- 4 Replace HVAC piping.
- 5 Replace EMS.

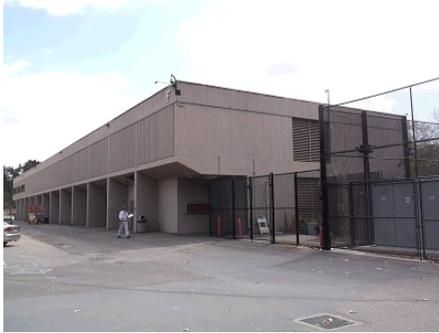
Facility: \Peralta Community College Dist\Merritt College\0004 LOCKER - F
Address: 12500 Campus Dr., Oakland, CA 94619

- 1 Replace drinking fountains.
- 2 Replace 52 showers.
- 3 Replace metal toilet partitions.
- 4 Replace AHU.
- 5 Replace HVAC piping.
- 6 Replace EMS.

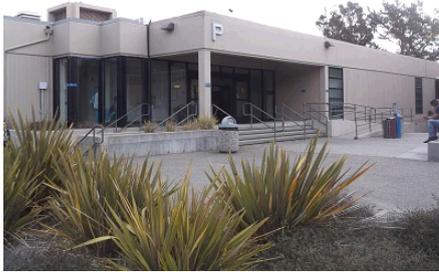
Facility: \Peralta Community College Dist\Merritt College\0005 BUSINESS - P
Address: 12500 Campus Dr., Oakland, CA 94619

1 Replace water heater.

- 2 Replace circulation pump.
- 3 Replace tile, m room P-207. 135 SF.
- 4 Replace emergency exit signage.
- 5 Replace HVAC piping.
- 6 Replace EMS.

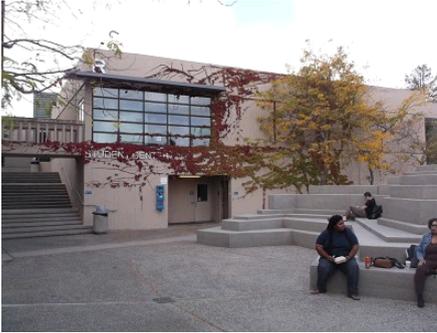
Facility: \Peralta Community College Dist\Merritt College\0007 CAMPUS CENTER R
Address: 12500 Campus Dr., Oakland, CA 94619

- 1 Repair leak, AHU room 207.
- 2 Replace door, room 12.
- 3 Replace emergency exit sinage.
- 4 Replace HVAC piping.
- 5 Replace EMS.

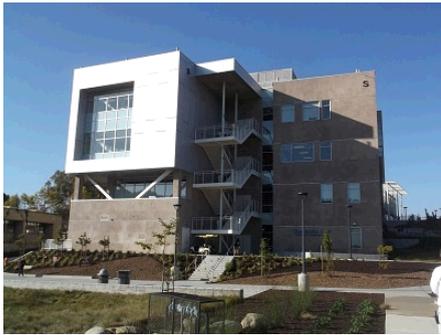
Facility: \Peralta Community College Dist\Merritt College\0008 SCIENCE/ALLIED HEALTH

1 Sink leak room S112.

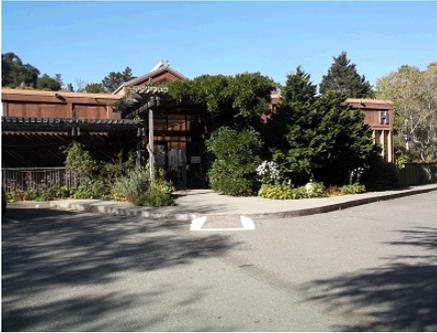
Facility: \Peralta Community College Dist\Merritt College\0015 LANDSCAPE HORT - H
Address: 12500 Campus Dr., Oakland, CA 94619

- 1 Replace drinking fountain.
- 2 Replace emergency phone.
- 3 Replace HVAC piping.
- 4 Replace AHU.

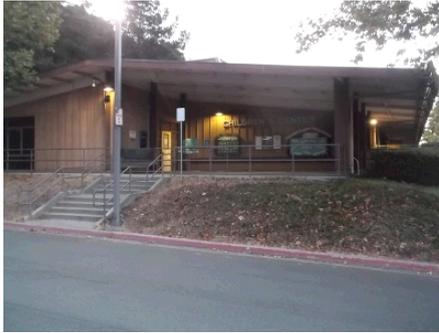
Facility: \Peralta Community College Dist\Merritt College\0022 CHILDRENS CENTER
Address: 12500 Campus Dr., Oakland, CA 94619

1 Replace emergency phones.
